New Hampshire Volunteer Lake Assessment Program

2003 Interim Report for Kezar Lake North Sutton

NHDES
Water Division
Watershed Management Bureau
29 Hazen Drive
Concord, NH 03301

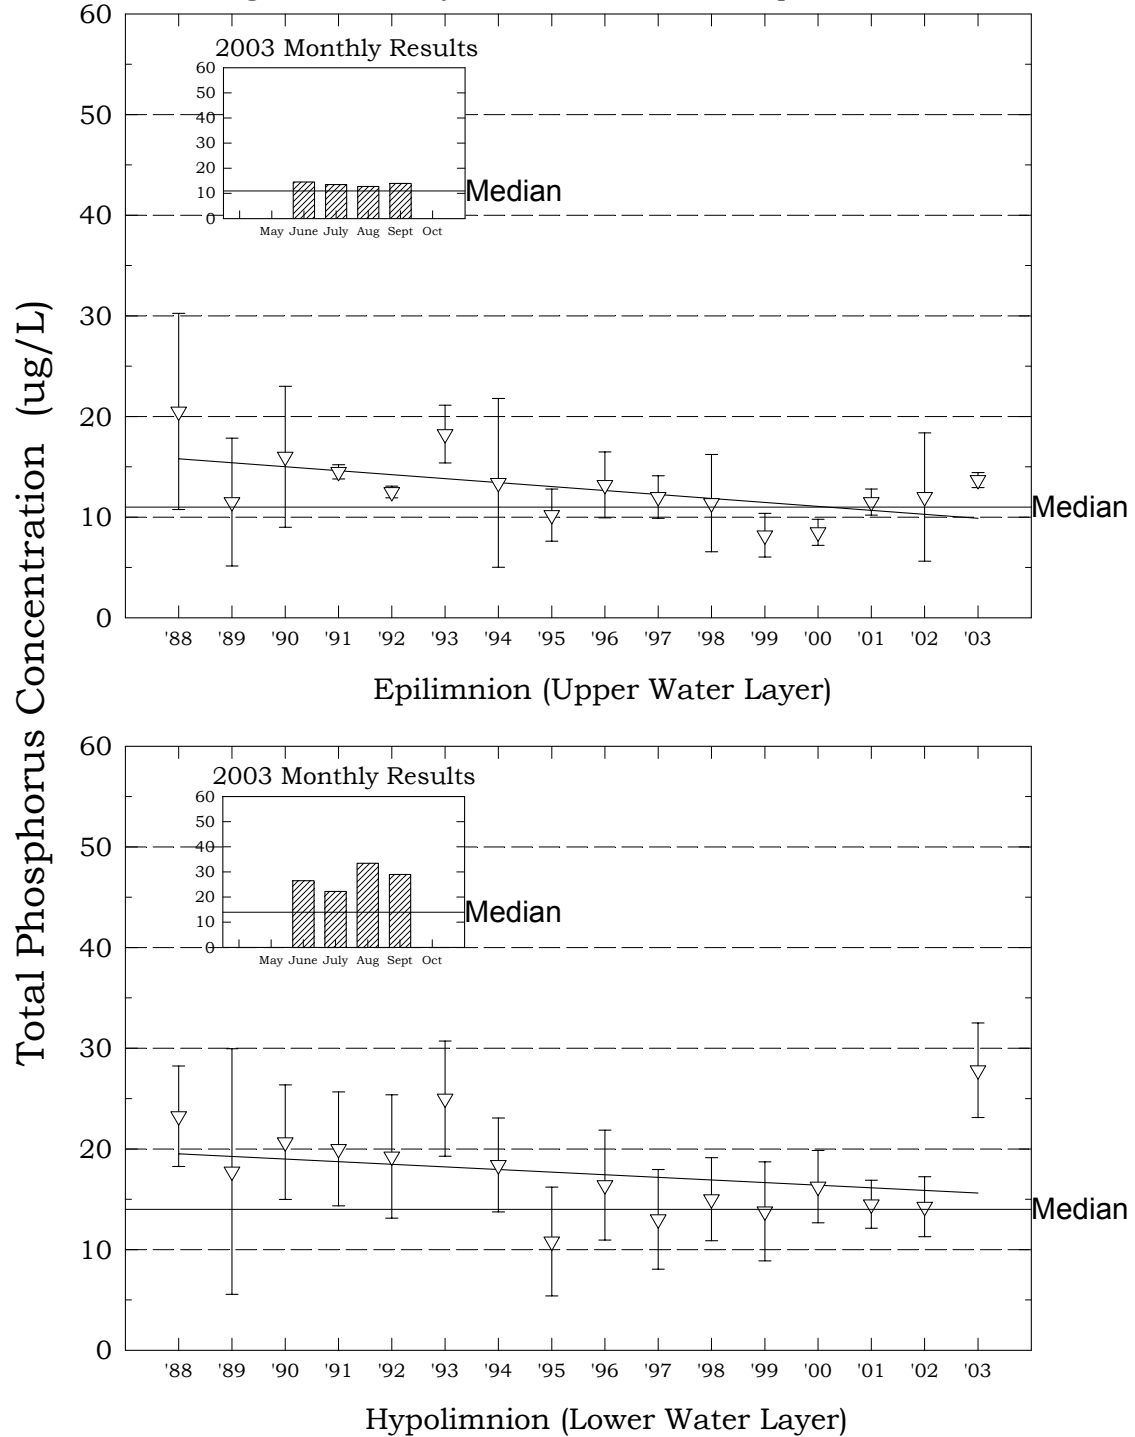
Figure 3. Monthly and Historical Total Phosphorus Data.

- **Figure 3 and Table 8:** The graphs in Figure 3 (Appendix A) show the amounts of phosphorus in the epilimnion (the upper layer) and the hypolimnion (the lower layer); the inset graphs show current year data. Table 8 (Appendix B) lists the annual maximum, minimum, and median concentration for each deep spot layer and each tributary since the lake/pond has joined the program.

The current year data for the epilimnion (the top inset graph) show that the mean monthly phosphorus concentration **remained relatively stable** from June to September.

The historical data show that the 2003 mean epilimnetic phosphorus concentration is **slightly greater than** the state median.

The current year data for the hypolimnion (the bottom inset graph) show that the mean monthly phosphorus concentration **decreased** from June to July, **increased** from July to August, and then **decreased** from August to September. The mean monthly phosphorus concentration was **greater than** the state median for each month.

It is important to point out that the annual mean hypolimnetic phosphorus concentration this year was the **highest** annual mean (27 ug/L) since monitoring began. The hypolimnetic phosphorus concentration was particularly **elevated** on the June 30 and August 4 sampling events (59 and 60 ug/L, respectively). The turbidity of these samples was also **elevated** (2.47 and 6.3 NTUs, respectively). This suggests that the lake/pond bottom may have been disturbed by the anchor or by the Kemmerer Bottle while sampling. When the lake/pond bottom is disturbed, sediment, which typically contains attached phosphorus, is released into the water column. *When collecting the hypolimnion sample, please check to make sure that there is no sediment in the Kemmerer Bottle before filling the sample bottles.*

Overall, visual observation of the historical data show that the phosphorus concentration in the epilimnion (upper layer) and the hypolimnion (lower layer) has **decreased**, meaning *improved*, since monitoring began in 1988.

One of the most important approaches to reducing phosphorus loading to a waterbody is to continually educate watershed residents about its sources and how excessive amounts can adversely impact the ecology and value of lakes and ponds. Phosphorus sources within a lake or pond's watershed typically include septic systems, animal waste, lawn fertilizer, road and construction erosion, and natural wetlands.
